Home Inspection Report

Your New Home

Inspection Address: Your New Home
Report Number: 10-00000

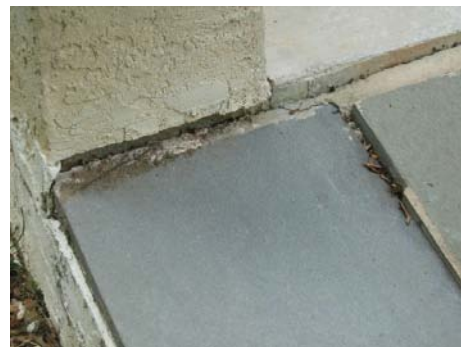
- **Safety Issue:** The patio flagstone has settled in various locations. Repairs are recommended since the settlement is creating trip hazards.

Settled Patio Flagstone (typical)

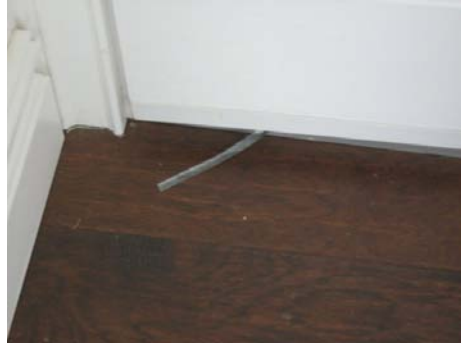
- **Repair:** The side entrance door and the garage passage door present damaged threshold weather stripping. The weather stripping for the doors should be replaced.
- **Repair:** The deadbolt for the basement walkout door should be adjusted for proper operation.

Damaged Weather Stripping

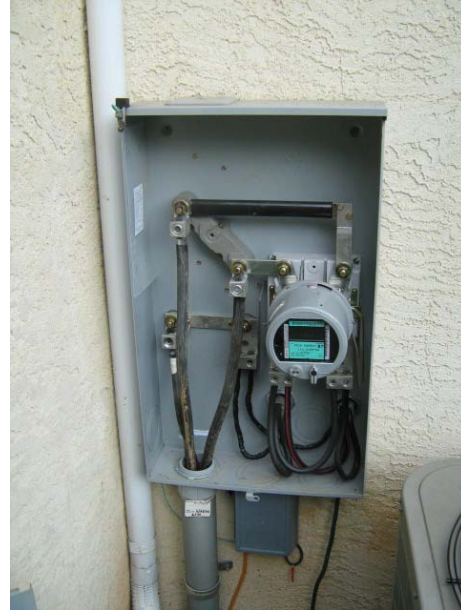
- **Repair:** A jumper wire should be installed across the water heater supply pipes to ensure proper bonding of the piping system.
- **Safety Issue:** The anti tamper device for the access panel at the electric meter is missing. The panel is easily removed, exposing various high voltage connections. The electric utility should be notified of this condition before settlement. Note: Any means of locking the panel should conform to local electric and fire safety codes.

Open Meter Box
