Home Inspection Report

Your New Home

January 1, 2010

ValueGuard USA, Inc.
856-429-4188

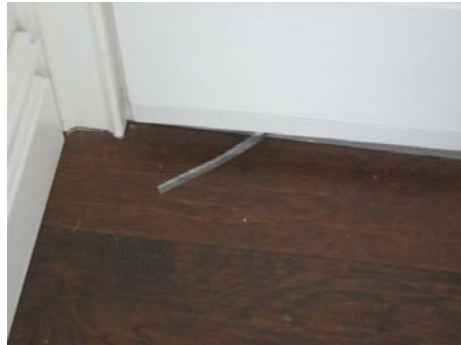
- **Repair:** The side entrance door and the garage passage door present damaged threshold weather stripping. The weather stripping for the doors should be replaced.
- **Repair:** The deadbolt for the basement walkout door should be adjusted for proper operation.

Damaged Weather Stripping

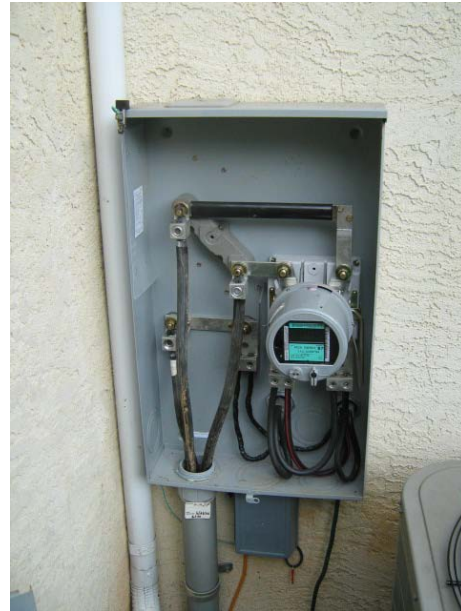
- **Repair:** A jumper wire should be installed across the water heater supply pipes to ensure proper bonding of the piping system.
- **Safety Issue:** The anti tamper device for the access panel at the electric meter is missing. The panel is easily removed, exposing various high voltage connections. The electric utility should be notified of this condition before settlement. Note: Any means of locking the panel should conform to local electric and fire safety codes.

Open Meter Box

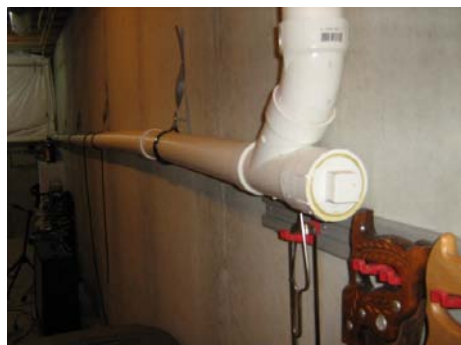
- **Repair:** The waste piping at the basement wall (east side) does not have sufficient slope for proper drainage.

Improperly Sloping Waste Piping
