# Building Inspection Report

## Your New Home

**Report Number:**  
10-00000

**Inspection Address: Your New Home**  
**Report Number: 10-00000**

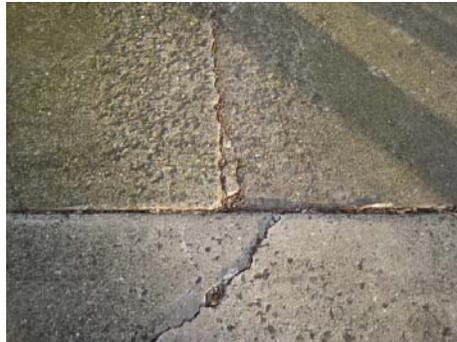
- **Repair:** The soil below the driveway at the front wall has settled and/or heaved. Persisting movement may result in the need for resurfacing.

Cracked Driveway

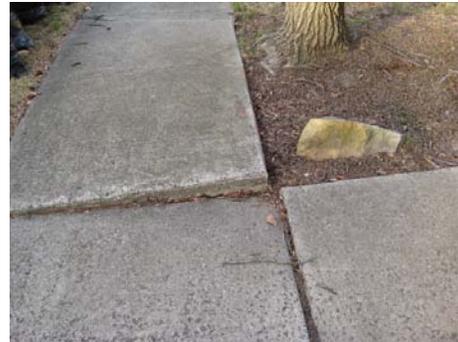
- **Safety Issue:** The walkway at the front wall presents a trip hazard. This condition should be altered for improved safety.

Trip Hazard (Front Walk)

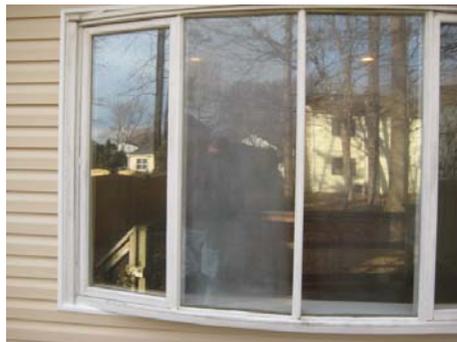
- **Major Concern:** The bay windows at the front and rear walls have lost their seal. This has resulted in condensation developing between the panes of glass. Repairs are recommended.

Broken Window Seal at Bay Window

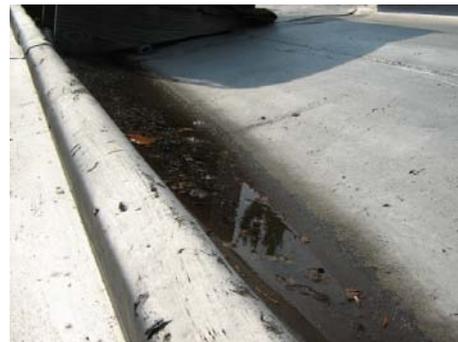
- **Repair:** Water is ponding at the eave edge near the air conditioner condensers. This area should be repaired to maintain the slope towards the roof drain.

Water Pond @ eve

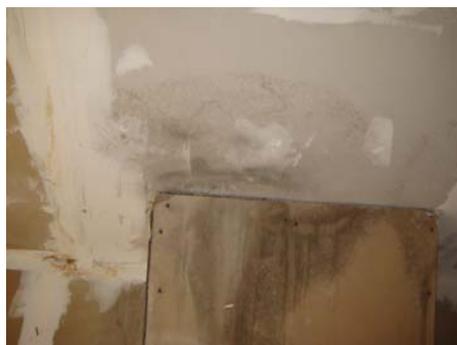
- **Major Concern:** The flashing at the chimney is damaged and should be repaired to avoid further leaks into the garage. See the photo at the end of this report.

Water Leak in Garage from Chimney

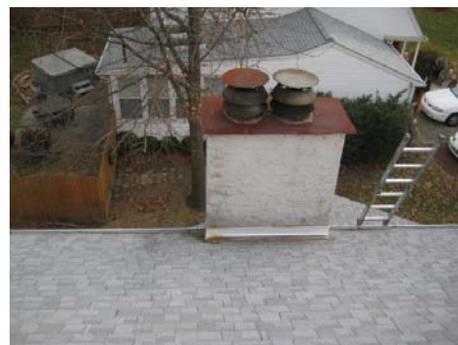
- **Monitor:** The masonry chimney at the chimney shows evidence of normal wear and tear.
- **Repair:** The metal chimney cap is rusting. It should be painted with an appropriate paint or replaced.
- **Repair:** The masonry chimney side slope is in need of a cricket installed behind it to help direct water into the gutters.

Rusted Chimney Cap

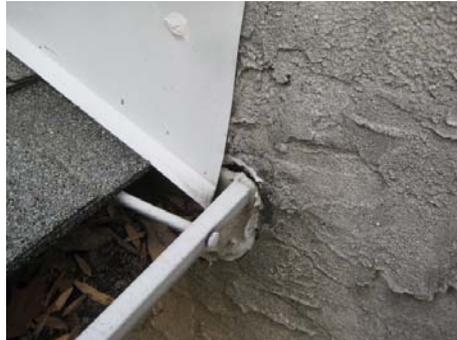
Hole in Flashing at Chimney

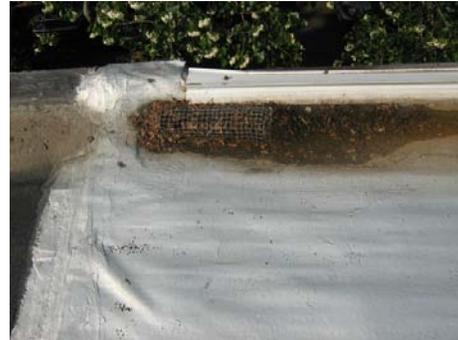
Blocked Drain

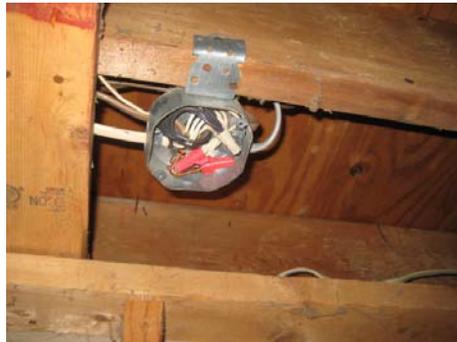
- **Safety Issue:** All junction boxes should be fitted with cover plates, in order to protect the wire connections.
- **Safety Issue:** An outlet in the kitchen is loose. It should be replaced
- **Safety Issue:** It is suspected that the batteries in the smoke detectors are defunct. This should be investigated.

Open Junction Box

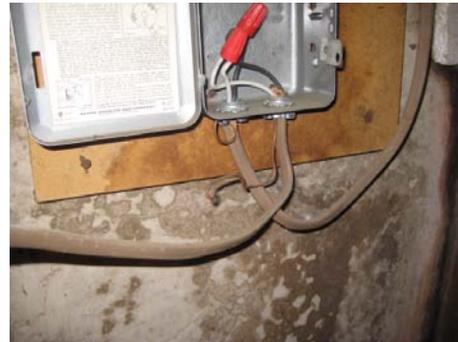
Ground Not Connected

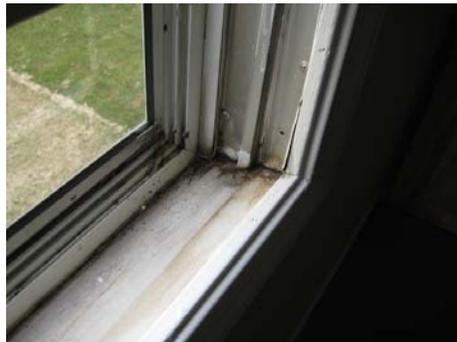
- **Repair:** The sliding glass door at the rear wall requires caulking.
- **Major Concern:** The windows in the rear bedrooms and master bedrooms show evidence of substantial rot to the window sills and frames. Repair to the windows can usually be accomplished by a skilled carpenter; however a replacement window is preferred in most cases.

Rotted Sill in Master Bedroom

Window Replacement.....\$250-300 (Each)  
 Bay Window Improvements .....\$2000-3000 each

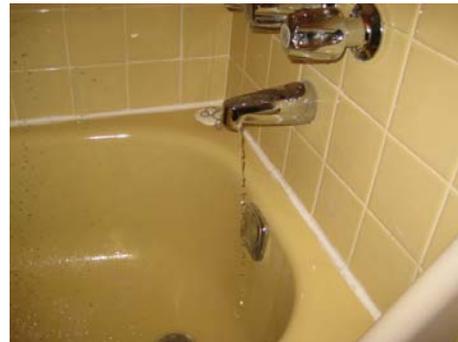
- **Repair:** The shower diverter is leaky and should be repaired.
- **Repair:** The sink is loose in the second floor hall bathroom and should be secured.

Diverter Leak

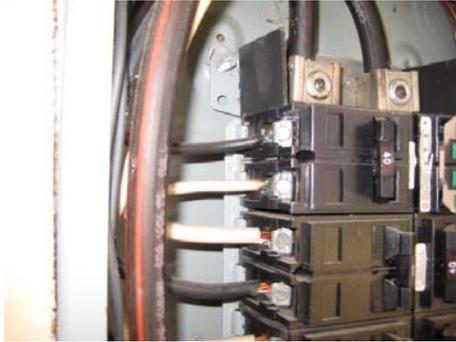
- **Major Concern:** Overheated wiring within the main distribution panel should be examined by a licensed electrician and repaired as necessary.

Scorched Wires

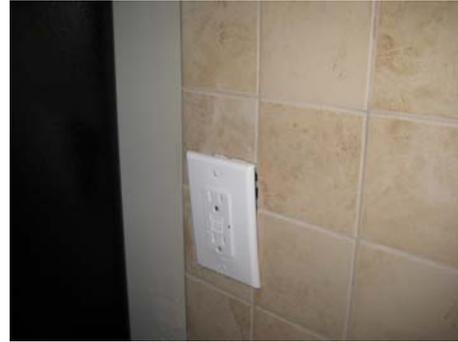
- **Safety Issue:** An outlet in the kitchen is loose. It should be replaced.

Loose Outlet

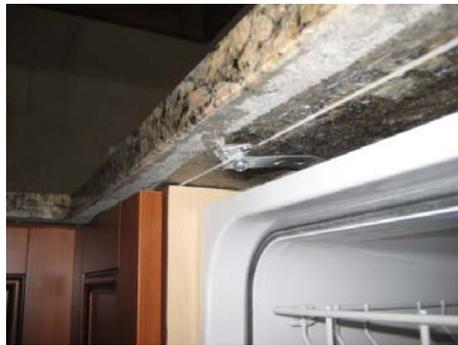
- **Repair:** The dishwasher should be better secured.

Dishwasher Loose
